Surface Water Hydrology and Flood Recurrence in the Flagstaff, Arizona Area, 2008-2019

April 22, 2021

Edward R. Schenk R.G. C.F.M. Stormwater Project Manager

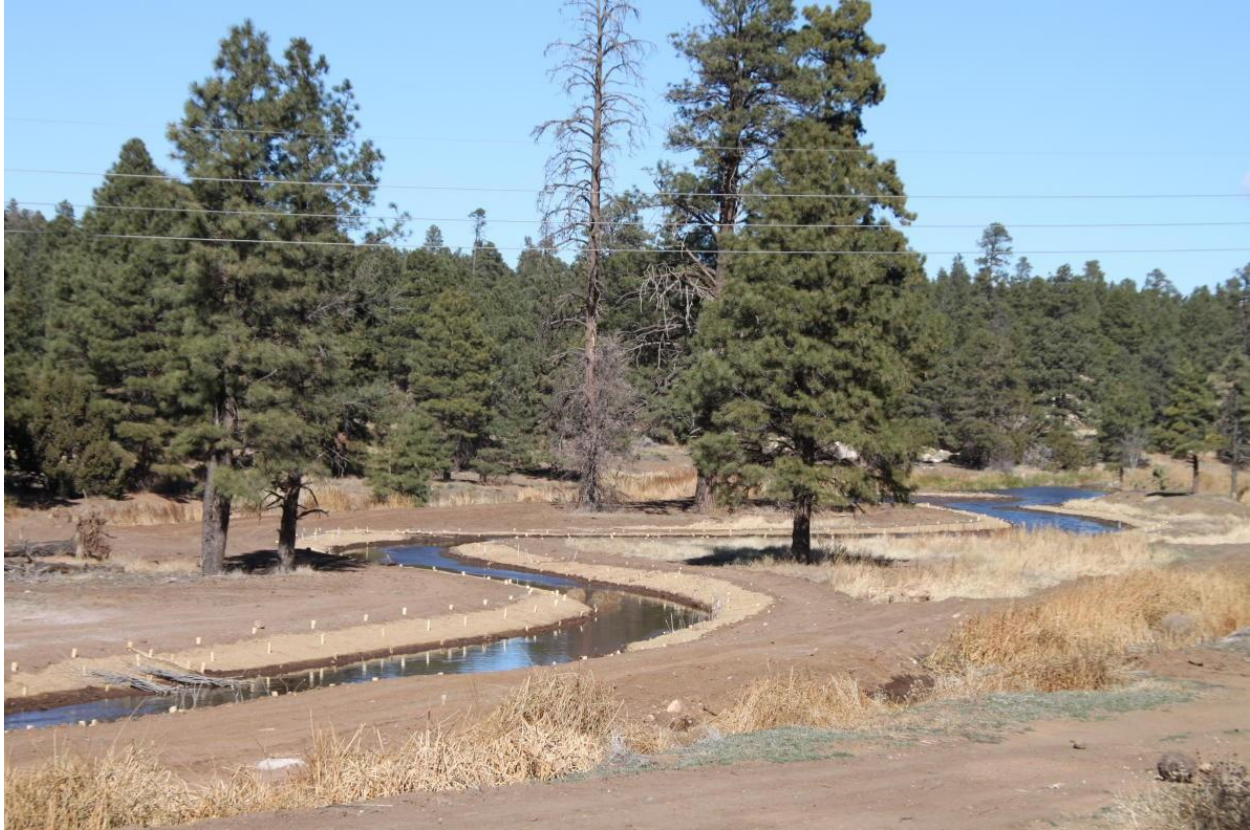
Figure 4. Rio de Flag channel restoration in Picture Canyon Preserve.

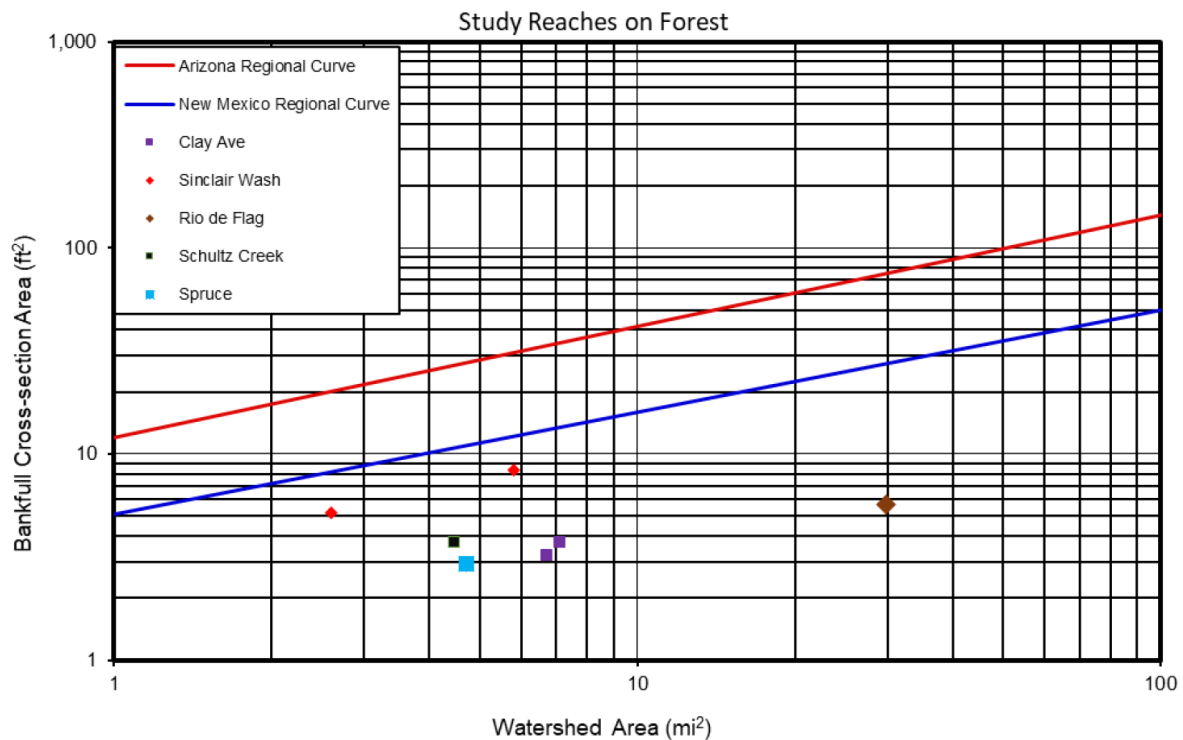
Figure 5. Regional geomorphic curves for the Southwest USA and representative Flagstaff streams (Natural Channel Design 2020). Note that Flagstaff stream channels are much smaller than reference streams.

There have been few studies of the geomorphology of the Flagstaff area but some recent projects in stream restoration have provided some background information on the topic. Local streams exhibit similar channel morphology to the region, channels that are defined by flashy monsoon storms more so than the longer duration gentle snowmelt periods (Moody et al. 2003). Many of the local streams do not show recent history of violent flooding, except within urban areas, and are defined by gravel beds and grassy slopes (Natural Channel Design, 2020). Stream incision, the act of channels down cutting abandoning their formal riparian area, is relatively uncommon in the Rio de Flag except in areas of extreme disturbance. Stream incision is a major problem throughout the Southwest but the Rio de Flag may have been partly spared by the high infiltration rates of the ponderosa forests and the local geology. While there are flash floods on the Rio it is rarer than true desert environments. The forest detritus, duff, and high elevation soils also help reduce violent flooding. The local channel capacity demonstrates the complacent watershed conditions, many of the channels are undersized for the catchment area (Figure 5).

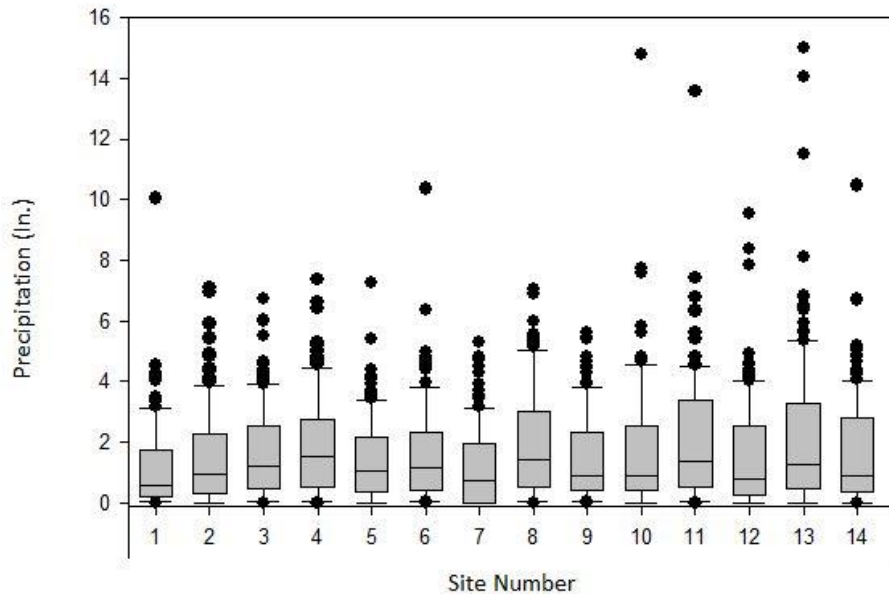
Peak Monthly Precipitation June 2010 - December 2019

- 1 - Flagstaff Landfill
- 2 - Airport Detention Basin
- 3 - Flagstaff Mall
- 4 - Peak View Street
- 5 - Francis Short Pond
- 6 - Clay Ave. Wash
- 7 - Foxglenn Park
- 8 - Mt. Dell Detention Basin
- 9 - Schultz Basin 4
- 10 - Waterline Rd #2
- 11 - Waterline Rd #1
- 12 - Schultz Basin 7
- 13 - Waterline Rd #3
- 14 - Schultz Basin 9

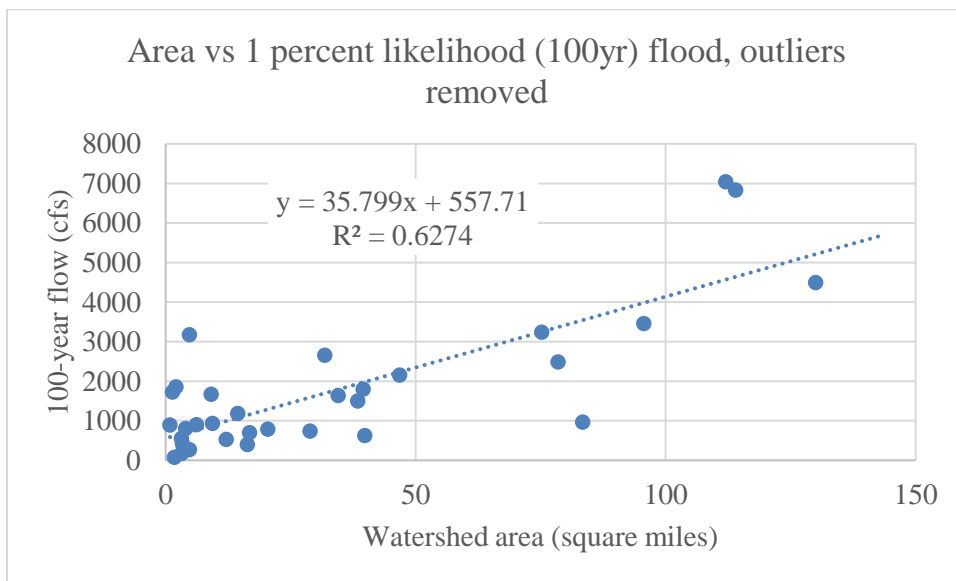
Figure 13. Design flood versus catchment area, three outlier values were removed.

A simplified regional flow curve was created using a sub-set of the USGS gauges used for the Arizona-New Mexico regional relationships (Paretti et al. 2014). The USGS sites comparable to the Flagstaff area were selected using a mean elevation greater than 7000 feet and a watershed contributing area no larger than 150 square miles. Period of record was from the gauge start date to end date or 2019 for existing gauges. The simple linear regression is provided below (Figure 11) as is the list of USGS sites selected for this analysis (Table 5).

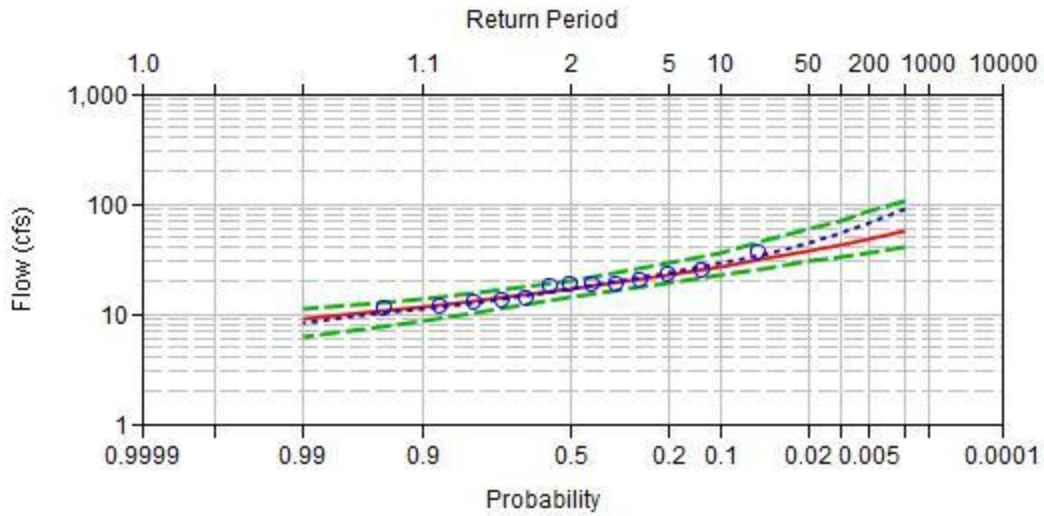
Bulletin 17 Plot for Peak View

- Computed Curve
- Expected Probability Curve
- - - 5 Percent Confidence Limit
- - - 95 Percent Confidence Limit
- Observed Events (Median plotting positions)

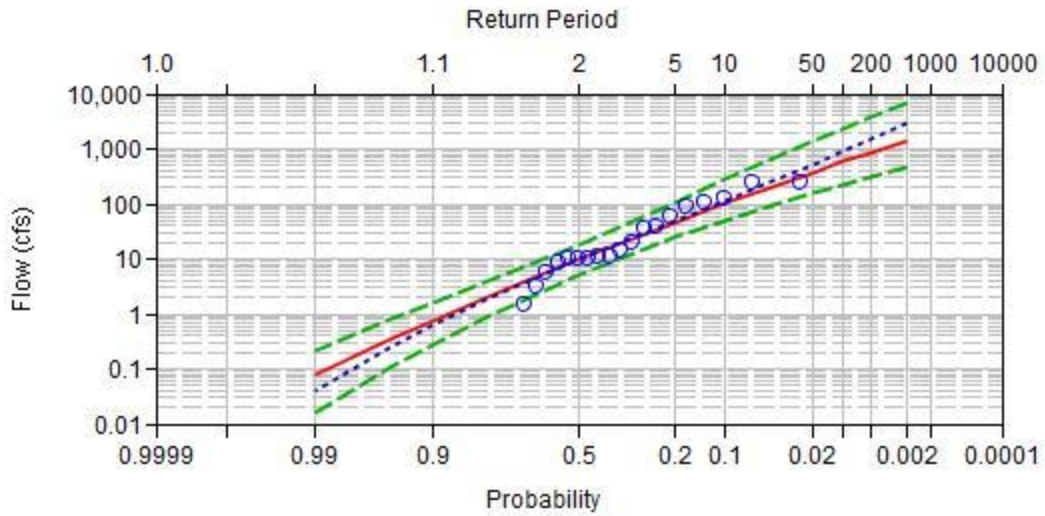
Bulletin 17 Plot for RDF at Crescent Ave.

- Computed Curve
- - - - - Expected Probability Curve
- - - - - 5 Percent Confidence Limit
- - - - - 95 Percent Confidence Limit
- Observed Events (Median plotting positions)

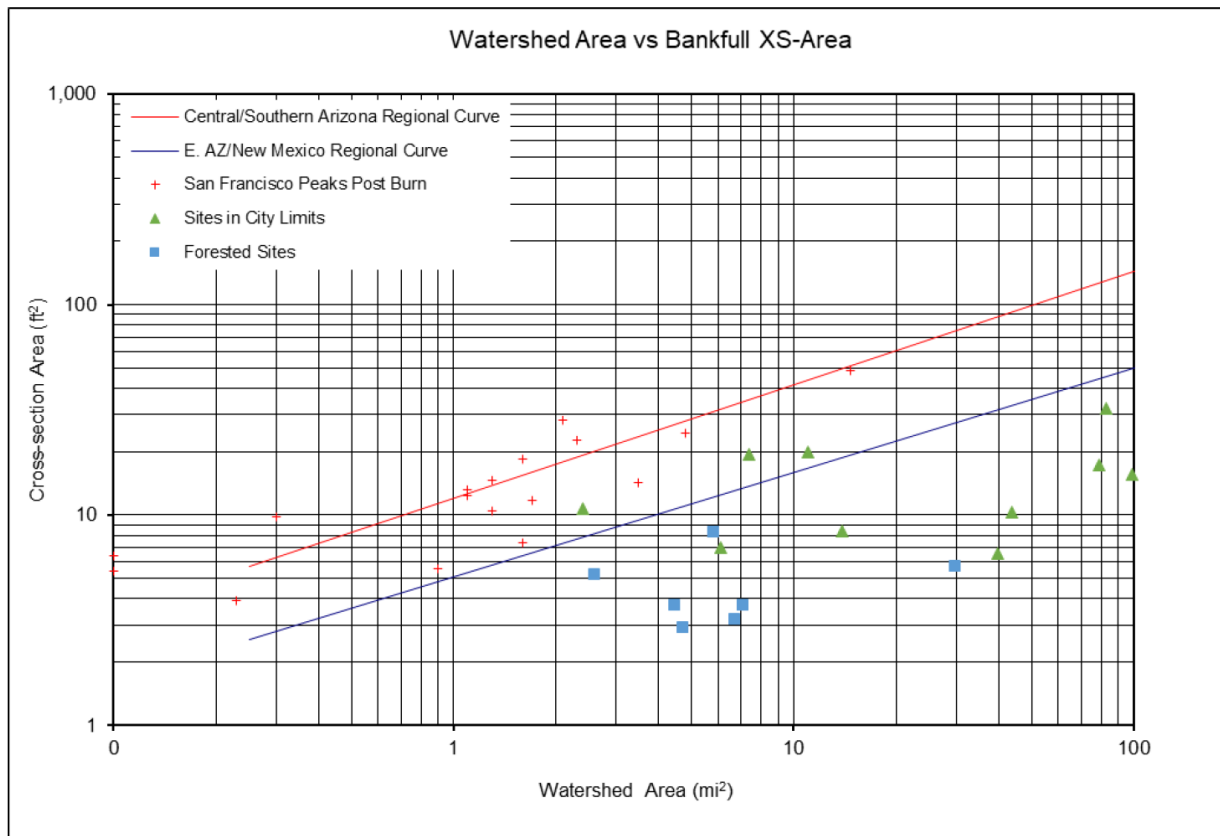
Figure 14. Local channel capacity (y-axis) compared to watershed area (x-axis) for local streams. The 2010 Schultz Fire impacted streams are also shown as red crosses (Figure from Natural Channel Designs 2020).
