Flagstaff Area Stream Fluvial Geomorphology Gaged Site Analysis

November 2021

Edward Schenck
City of Flagstaff, Stormwater Section
2323 N. Walgreens St., Suite 1
Flagstaff, Arizona, 86004

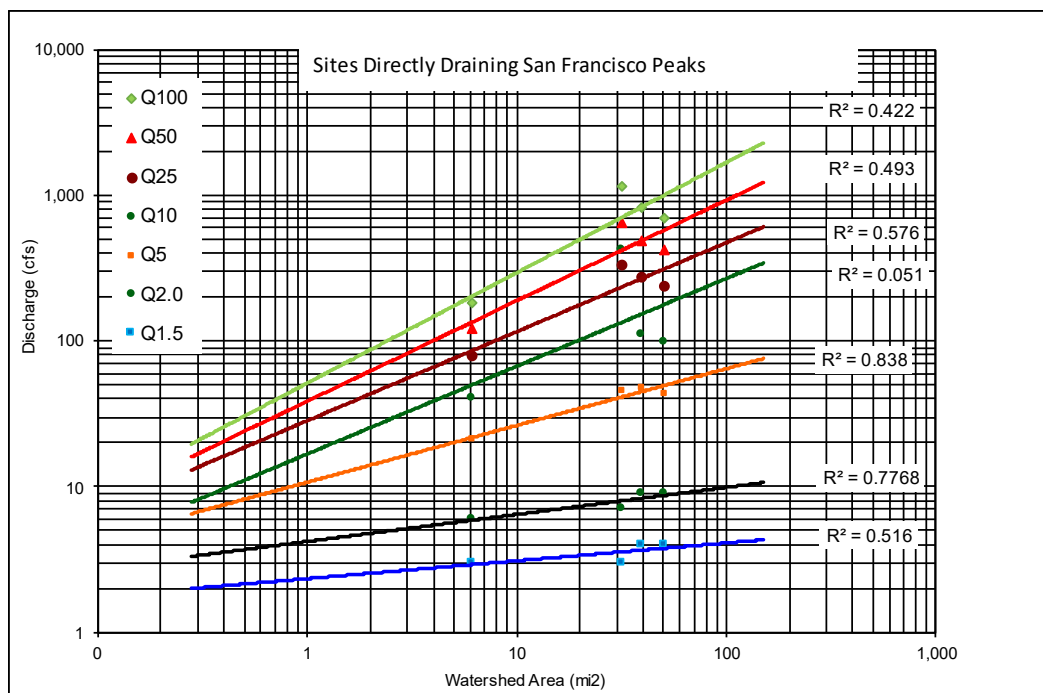
Figure 2. Graph of SF Peaks drainage flood frequency.

The first flow regime includes watersheds feeding the Rio de Flag and Schultz Creek. These watersheds are located mainly on the Coconino National Forest and originate off the western slopes of the San Francisco Peaks and surrounding land to the north of town, however, recently burned drainages were avoided. Three historic USGS gages and a city monitored gage were used to create a local flood frequency graph of the San Francisco Peaks drainages. The three original USGS sites are no longer in use, but NAU has installed crest stage gages at or near those sites. More recent peak flow data collected by City at the NAU sites was added to the original USGS data at these sites to increase the total number peak flow data points and improve the flow discharge predictions (Table 3 and Figure 2).

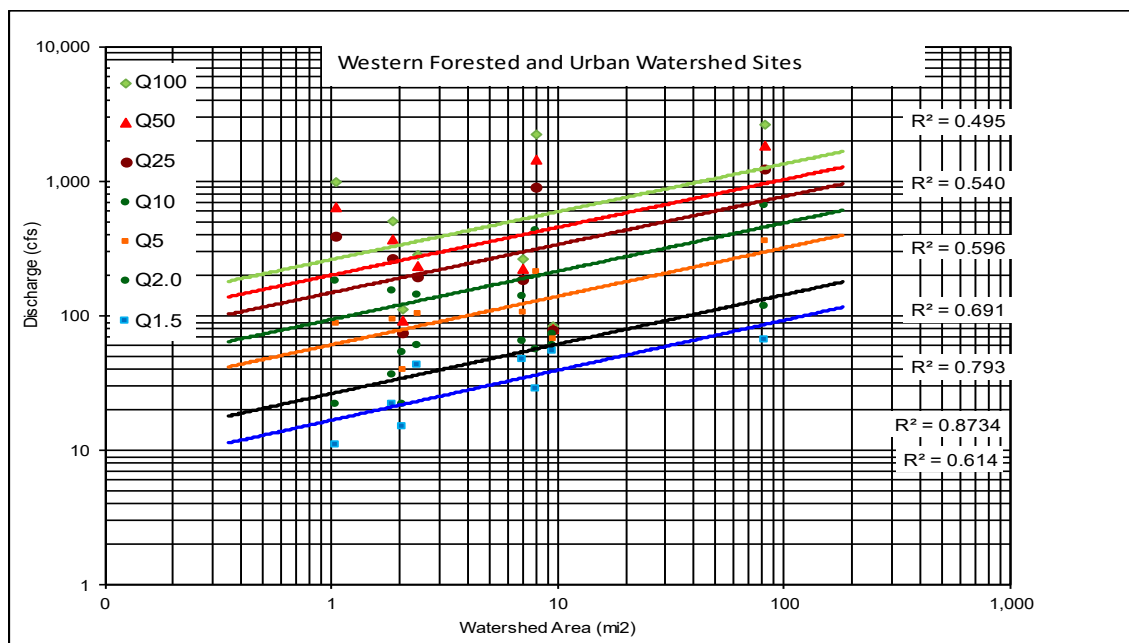
Figure 3. Graph of the Western and Urban drainages flood frequency

The second area includes the watersheds draining from the west or where there is a significant amount of urbanization and stormwater conveyance infrastructure within the city (Table 4 and Figure 3). The results of the flood frequency show a significant increase in the return interval discharges for the more urban watersheds compared to the on-forest ones, especially for the more frequent, lower discharge storms. There is much more variability in the urban and western drainage flood frequencies due to the varying amounts of urbanization and stormwater routing.

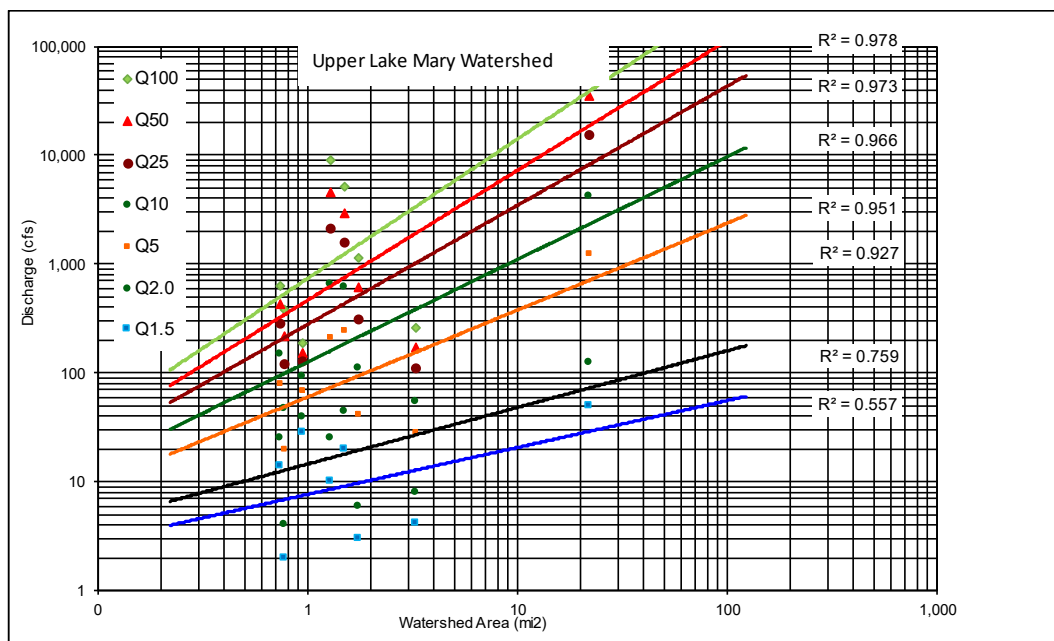
Figure 4. Graph of Upper Lake Mary drainage flood frequency.

The final set of data analyzed this year comes from the small sites on the Upper Lake Mary watershed (Table 5 and Figure 4). These sites are located southeast of Flagstaff in an area with more basalt parent material and greater depth to limestone compared with a more cinder soil and shallower depth to limestone that is seen to the west of Flagstaff. With the exception of Fay Canyon data, the rest of the sites only had between four and 8 years of data which is too little to produce a reliable flow frequency curve but can be used to start seeing trends for the watershed. Several more years of data are needed to produce statistically significant flow frequencies.

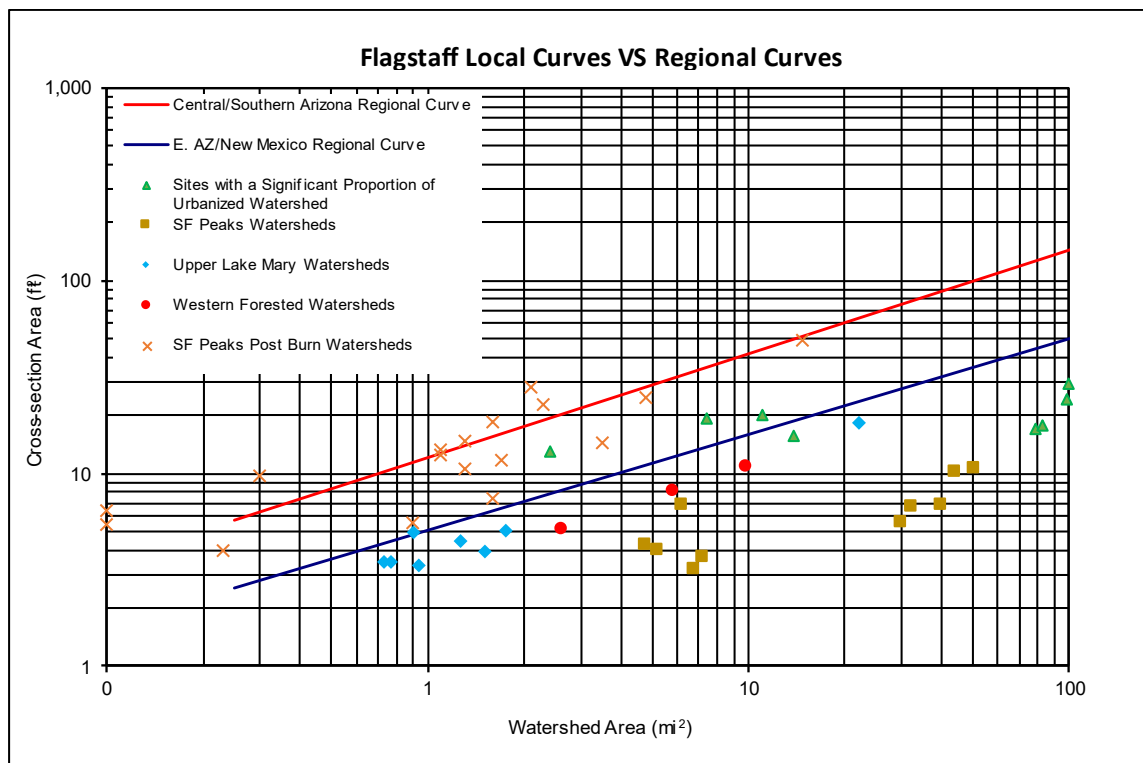
Figure 5. Bankfull Area Flagstaff local curve vs Regional Curve.

The data from the recently (2020 and 2021) surveyed stream channels were separated into four local zones: Sites that drain the San Francisco Peaks (SFP) without a significant portion of urbanization or recent burn history, Western Forested Sites (WF) that don't have a significant portion of urbanized watershed and are more managed, sites that have a significant portion of urbanized watershed (UW) and the Upper Lake Mary (ULM) sites. An additional data set of channel cross section data from significantly burned watersheds around the San Francisco Peaks is also included. This burn area data was collected as part of a different project in 2012 and the watersheds had been burned from 5 to 40 years prior to collection. The bankfull cross-sectional areas were graphed as a function of watershed area (Figure 5). Regional curve trendlines for Central/Southern Arizona as well as Eastern Arizona/New Mexico (Moody et. al. 2003) are included for reference.

As seen in Figure 5, the WF, UW and the ULM sites bracket the E. AZ and New Mexico curve. These sites would normally be expected to be trending closer along the Central Arizona curve and indicate a smaller channel than would be predicted given the geographic setting. The sites draining the SF Peaks can be separated into a separate curve which indicates bankfull area (and potentially discharge) are even lower than adjacent areas. Watersheds in the post burn data set would be expected to follow these regional trends. However, they are more closely aligned and generally indistinguishable from the Central Arizona curve. The post burn surveys indicate a tendency for an increase in bankfull cross-sectional area after a significant burn alters the forested environment assuming the pre-fire burn streams had a similar complacent watershed condition as the unburned areas. A summary of the bankfull areas of all the local sites surveyed in 2020 and 2021 and displayed in Figure 5 and provided in Table 7.

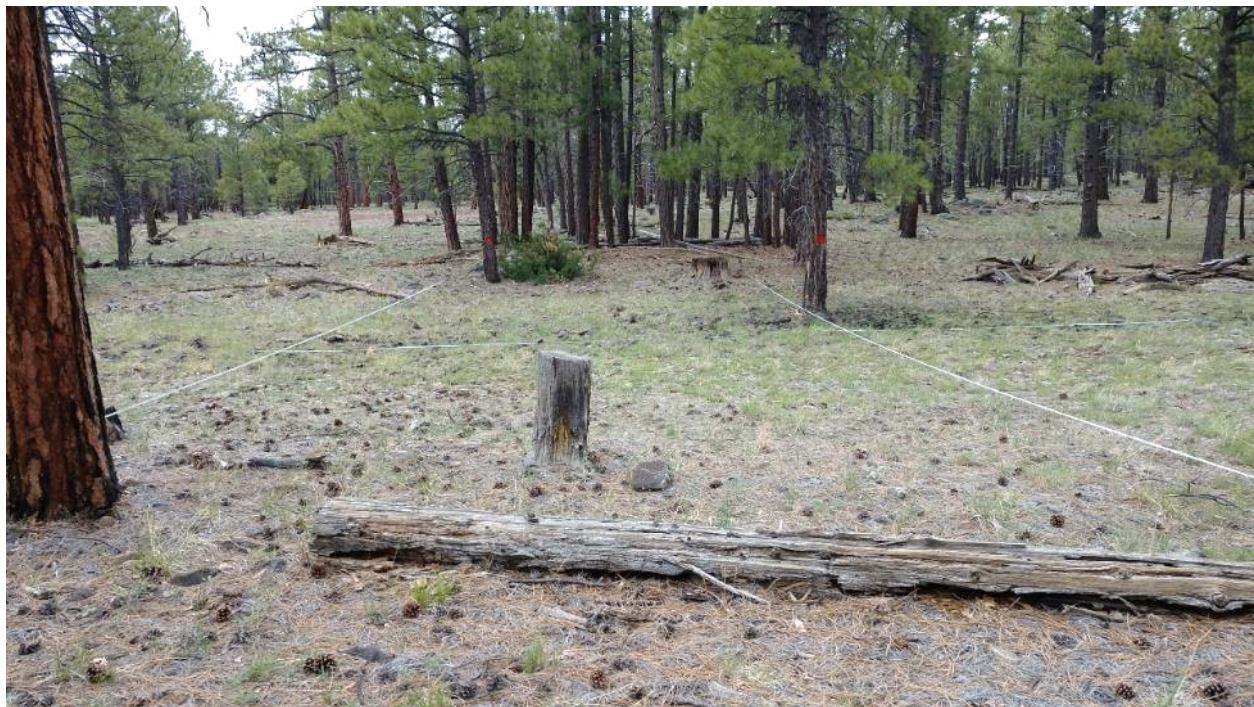
Figure 6: SRP Red Pins that Indicate the Location of Cross-Sections for Calibration

The existing stage vs discharge data for NAU, city, and SRP gages was provided by the city and allowed for a comparison between the existing rating curve and the rating curve developed through HEC-RAS modeling. The USGS gages are calibrated empirically but the NAU, City, and SRP gages were calibrated using hydraulic modeling. At each of the SRP gages, red pins indicate where previous cross sections were taken and were duplicated during this effort (Figure 6).

While cross-sections were surveyed at the three pinned locations, at least two more cross sections were surveyed along the reach. With additional cross-sections, the model is more comprehensive than with only three cross sections.

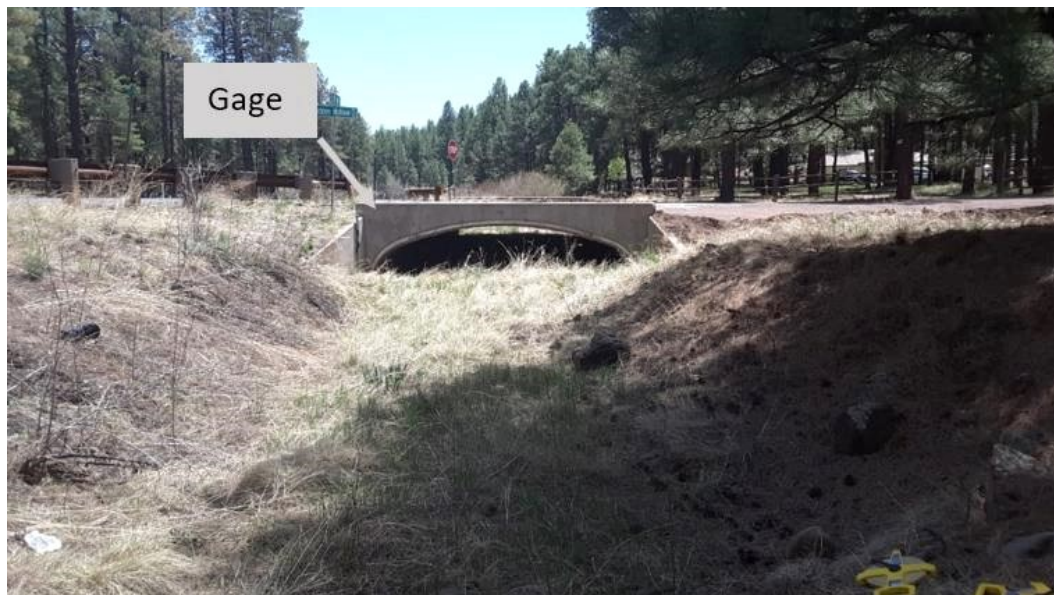
Figure 7. Crest stage Gage at Hidden Hollow Road

The gage at Hidden hollow is on the upstream side of a bridge and is expected to remain accurate up to the road overtopping event, stage 5.9 feet at the gage. Downstream of the bridge thick willow growth migrating upstream has the potential to alter downstream conditions which could cause the bridge to become outlet controlled rather than inlet controlled. In this scenario maintenance to the channel or adjustment to the HEC-RAS model would need to be done to obtain accurate results.

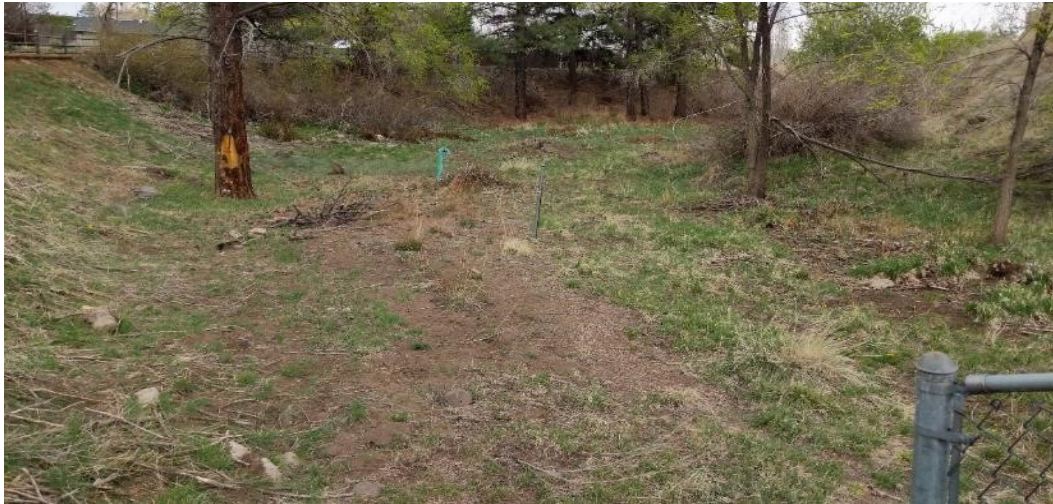
Figure 9. Crest stage gage downstream from Crescent Road.

The gage at NAU 2 is located in a single thread channel with no risk of overtopping away from the gaged channel. There is a three barrel 7' culvert associated with the gage and if any significant aggregation were to occur at this site results should be examined, and the model adjusted to reflect these changes. The culvert is steep enough that the HEC-RAS model is using a mixed flow regime, where it first runs a sub-critical flow and then a supercritical flow to determine if the critical depth is met at that flow. The model does use super critical flow to determine the flow through the culverts. If there is excess aggregation, especially on the downstream side, the slope through the pipes will be lessened due to pipe infill and the model should be updated as a critical flow may no longer be applicable. It should be noted that heavy vegetation in the channel could have an effect on flows in the future, especially if existing willows recruit and fill in thicker. The gage is located near recently trimmed willow trees and as these regrow, they will change flow characteristics. Manning's n may need to be updated as vegetation conditions change.

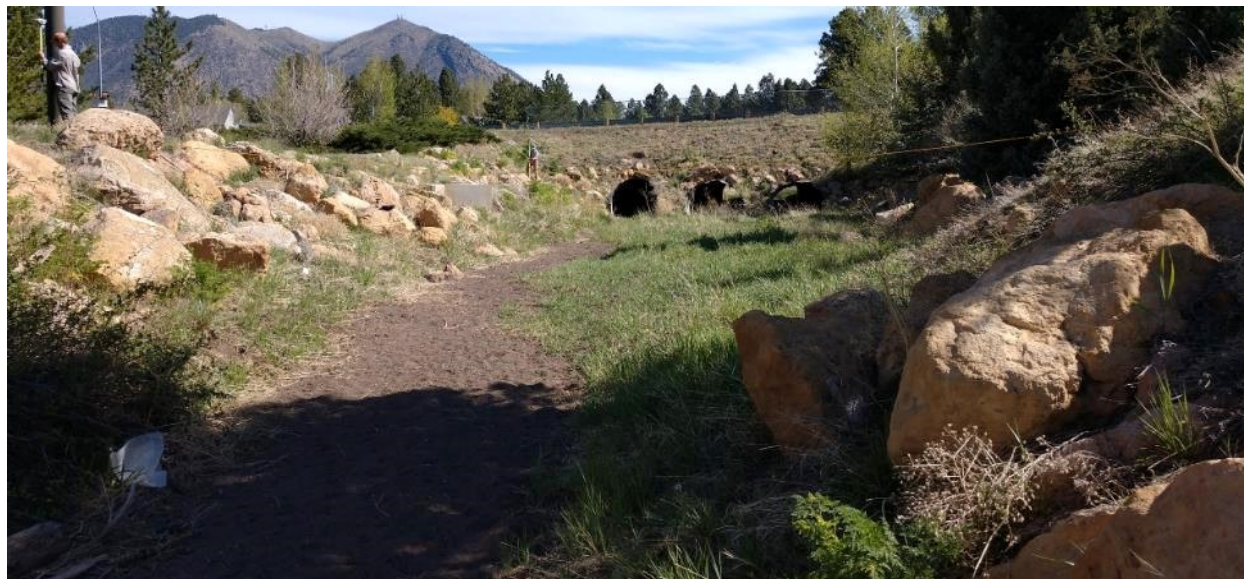
Figure 11. City of Flagstaff gage at Foxglenn Park.

The gage at Foxglenn is in a trapezoidal channel that does not have any willow or woody growth impeding flow. There is a relatively regular and consistent channel bottom. This gage is expected to remain accurate up to a stage of approximately 7 feet at which point water overtops the bank and spreads out. There is a culvert system passing underneath Butler Ave. and this is the most likely area where change due to aggregation or plugging could alter results. However periodic checks, especially following recent flooding, should be conducted to make sure no significant changes have occurred at the culverts.

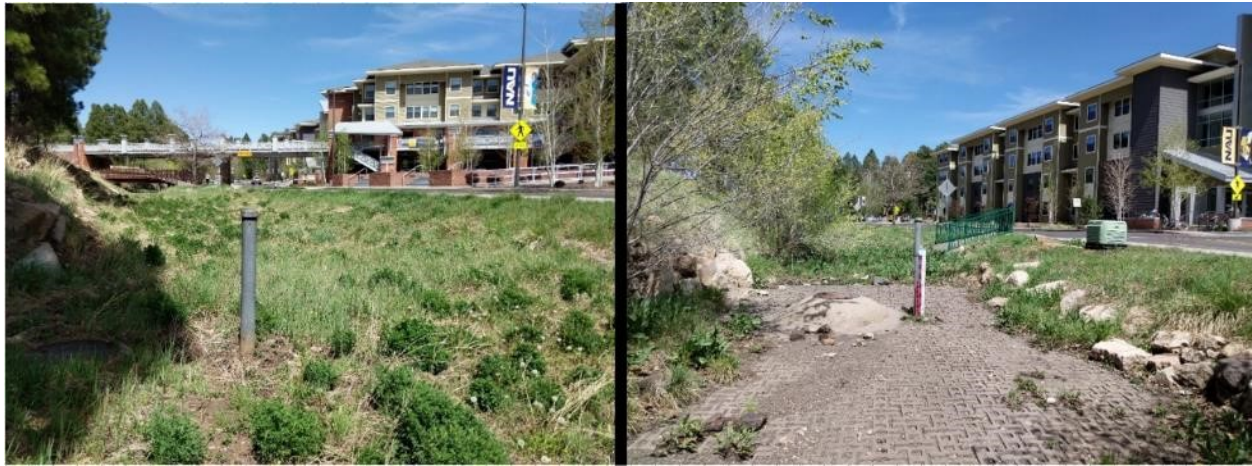
Figure 13. Crest stage gage downstream from Knoles Dr and Staff downstream from pedestrian bridge.

NAU 8 has two gages one located upstream and the other downstream from a pedestrian bridge. The river right side of the channel has a road and student housing complex. Flows producing a stage less than 3.3 feet deep will have the highest degree of accuracy, with all flow located in the channel. Flows exceeding this height will spill onto the road and portions may be trapped on the road by the curb and gutter section located there. The upstream gage is in a regularly maintained trapezoidal earth channel and the downstream gage is located in a stretch of articulated block with rock lined edges. Both sections of channel are unlikely to experience changes in channel geometry or cover. There is a bridge which in extreme cases may become clogged with debris and alter depths at the gages but this is unlikely in all but the largest events.

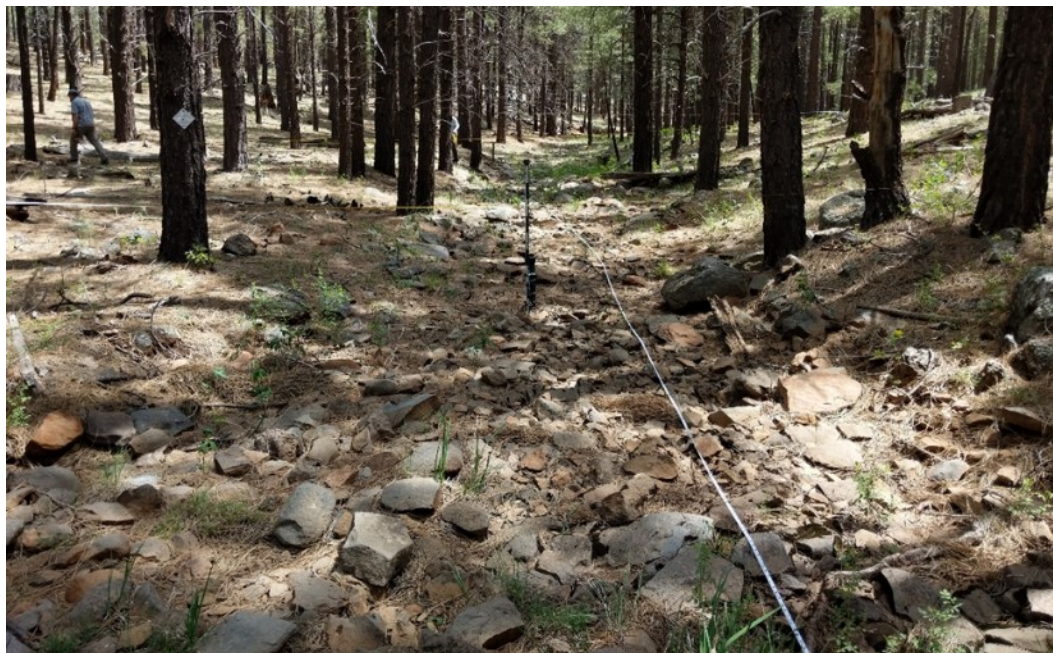
Figure 15. Gage at SRP 1.

The gage “SRP 1” is located in an area with a single thread channel leading in and out of the gage location. Additional cross sections were interpolated in HEC-RAS to improve model stability. The gage is accurate up to a stage height of 3.3 feet, at which point the channel spills into the wider valley beyond the cross-sections.

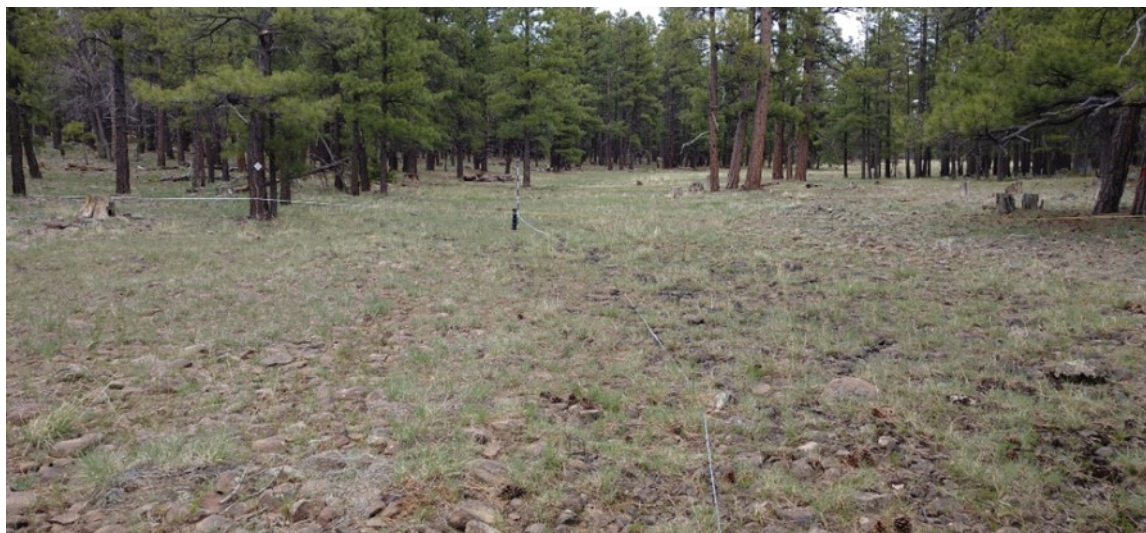
Figure 17. Gage at SRP-2

The gage “SRP 2” is located in a wide valley with a small, poorly defined channel in the center of the valley. The location is more of a meadow swale than a channel. At the gage cross-section the valley is 60 feet wide at 1 foot deep. This type of cross section is highly affected by even slight changes in Manning’s n values. Seasonal changes in vegetation or wet and dry years would have a large effect on discharge values. The HEC-RAS model is accurate in the current state, however the site would need to be observed to ensure accuracy at the time of the flow event. A fallen tree or large branch from a tree would likely have large effects on the flow in areas where flow is too shallow to move them even during large events. Would not recommend using this gage without checking site conditions near to time of the event.

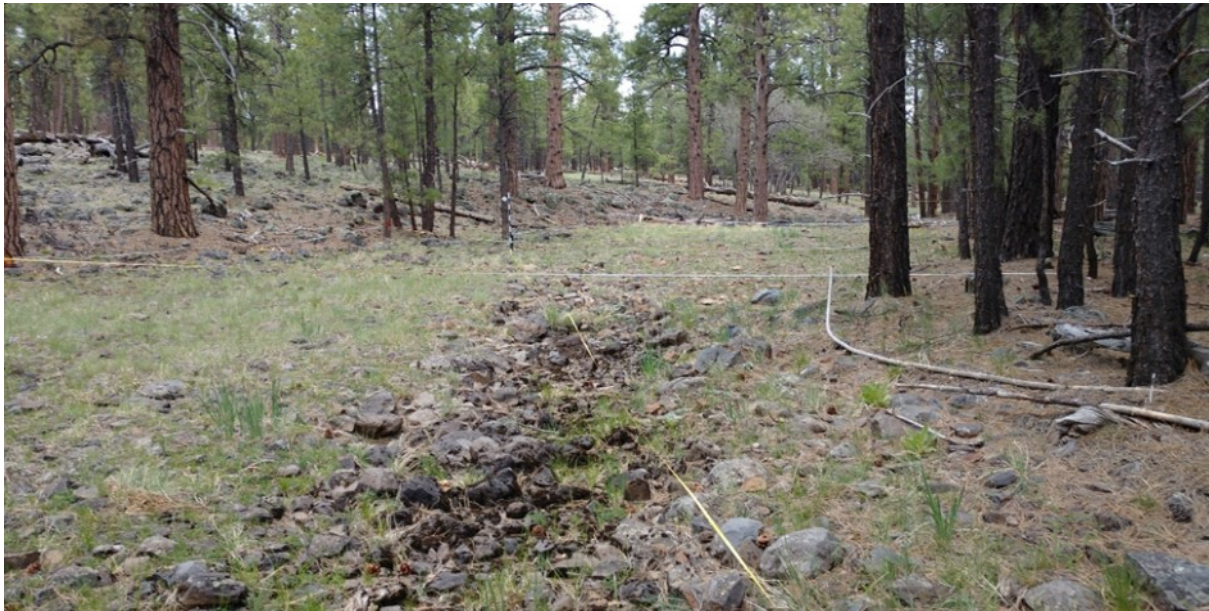
Figure 19. Gage at SRP3

The gage at SRP 3 is located in a shallow, wide channel. The gage is located in a minor constriction, downstream from where the meadow is wider and two separate channels converge. This gage is accurate to use, especially at moderate flows. During very low flows debris and changes in vegetation could have a large effect on accuracy.

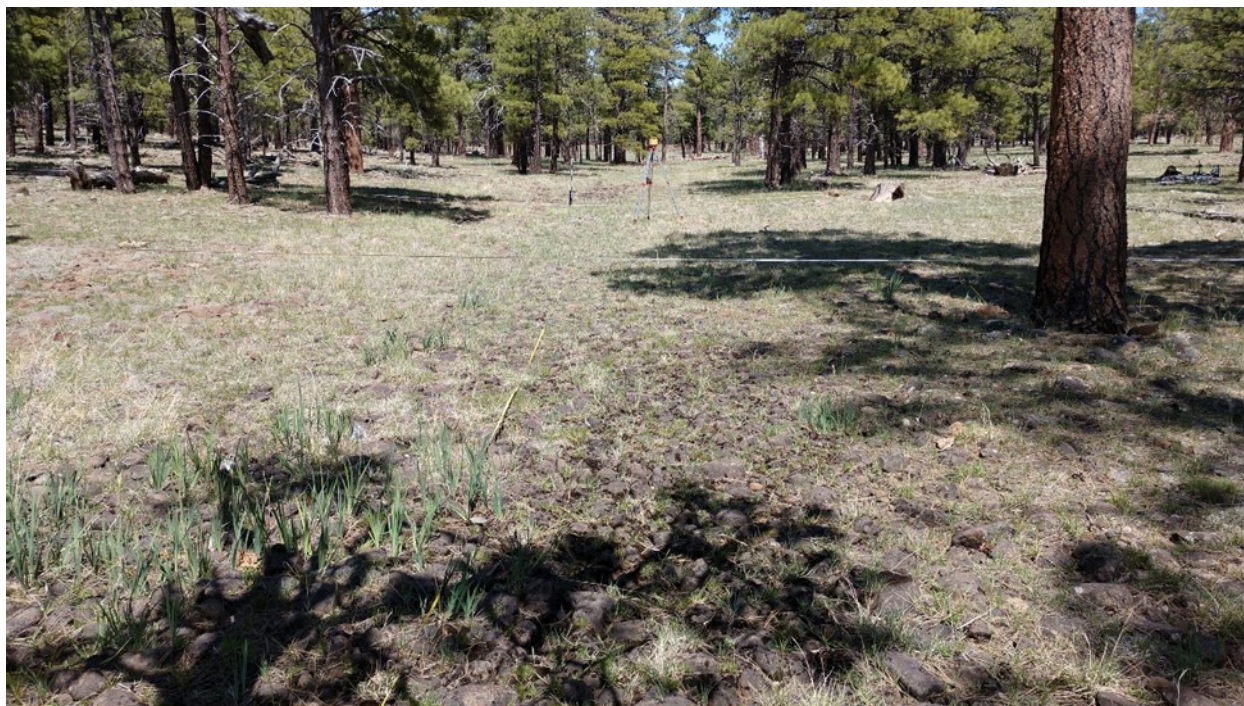
Figure 21. Gage at SRP 4.

The gage at SRP 4 is located in a small channel. Any stage greater than 0.9 feet spreads into a wider valley and begins to be heavily affected by slight changes in Manning’s n caused by debris deposits or fallen trees. The model indicates the gage will provide accurate results up to approximately 55 cfs and 0.9 stage height.

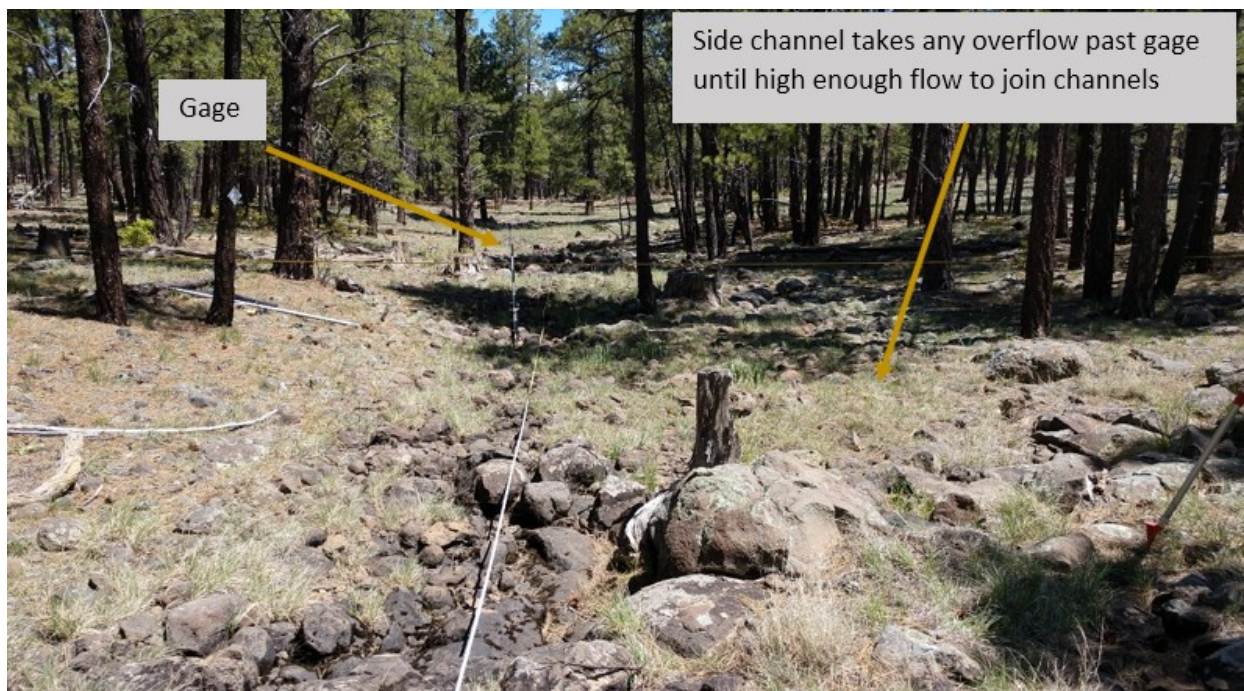
Figure 23. Gage at SRP 5.

SRP 5 gage is in a split channel which forms upstream at cross-section 2 at flows deeper than 0.9 feet above channel bed. This channel split means that some flow from the watershed could bypass the gage during storm events depending on upstream conditions. This gage may not be located in an area that would lead to consistent results in anything other than a large enough flow to join the multiple threads together.

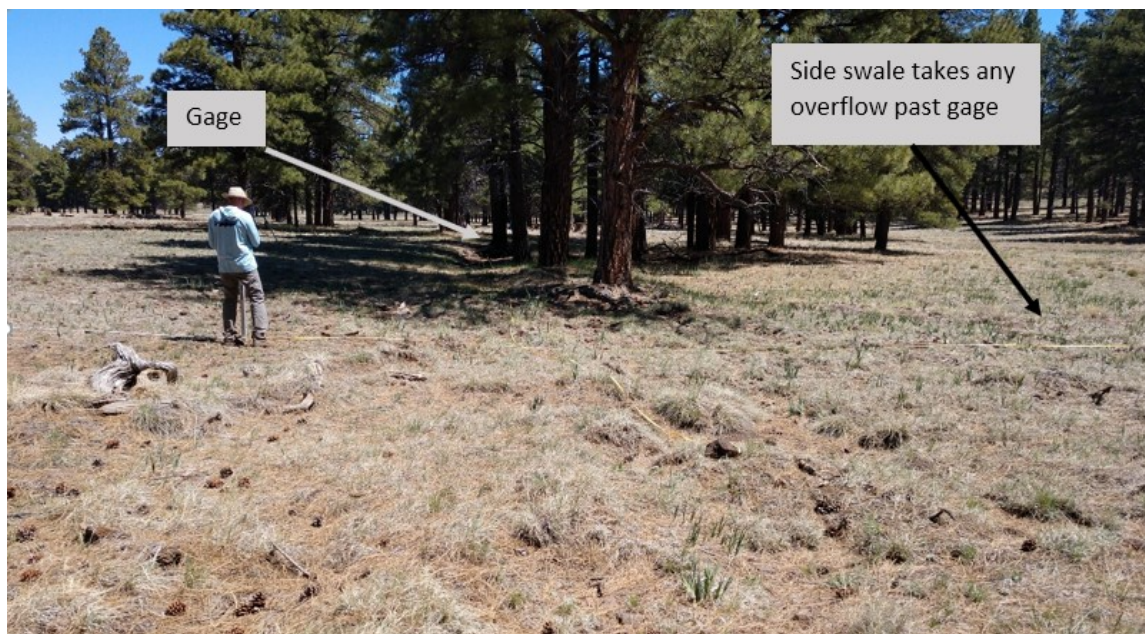
Figure 25. Looking downstream at cross-section 1, SRP 6.

The gage at SRP 6 is located in a wide valley that splits into a separate swale approximately 40 feet upstream of the gage location. Water can bypass the gage via a low swale along the right side of the channel. Any flows exceeding a stage of 1.6 feet or 48 cfs will not all be accounted for by the gage. The HEC-RAS model uses a lateral weir to model flows that leave the channel and do not return until below the gage reach. This location is acceptable for small flow events but any large events over approximately 48 cfs will not be accurately measured by this gage.

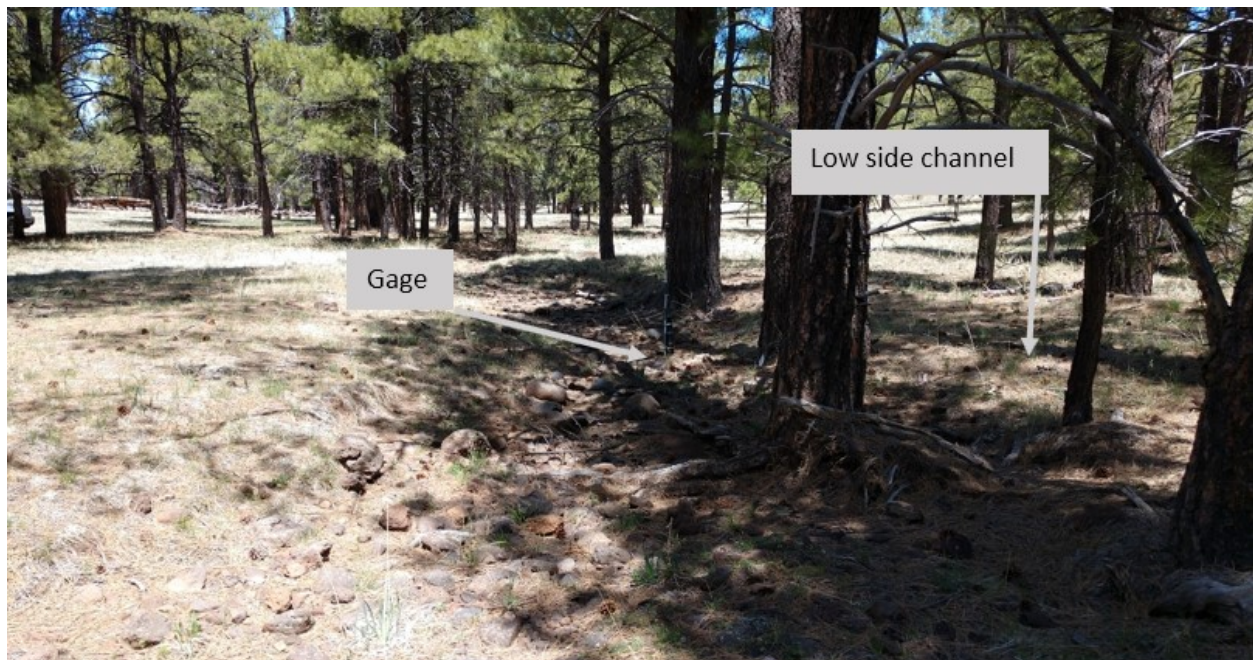
Figure 27. Gage at SRP 7

The SRP 7 gage is located in a split channel at high water and higher flows are not confined to the primary channel upstream of the gage site. This gage cannot accurately model flows because small flows may be in a side channel adjacent to the gage site and large flows could pass the site on the left side of the valley.

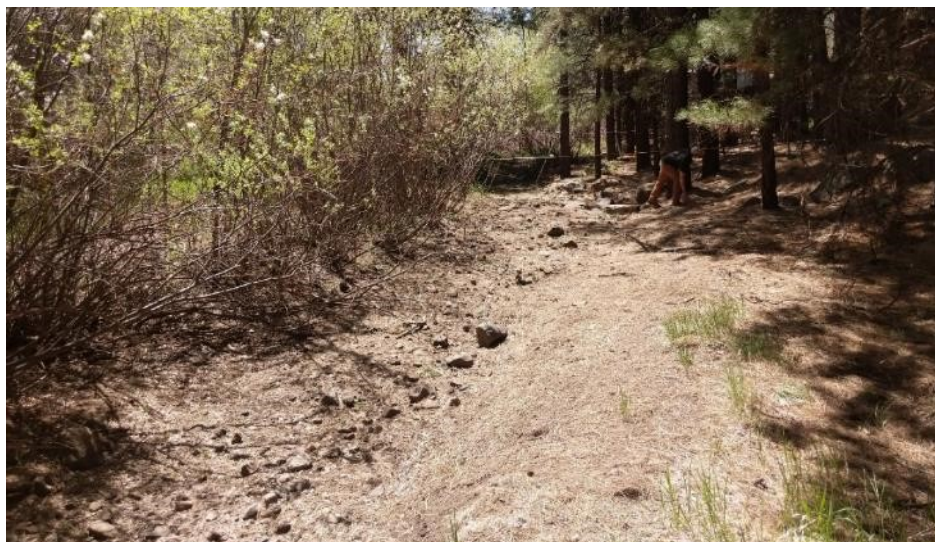
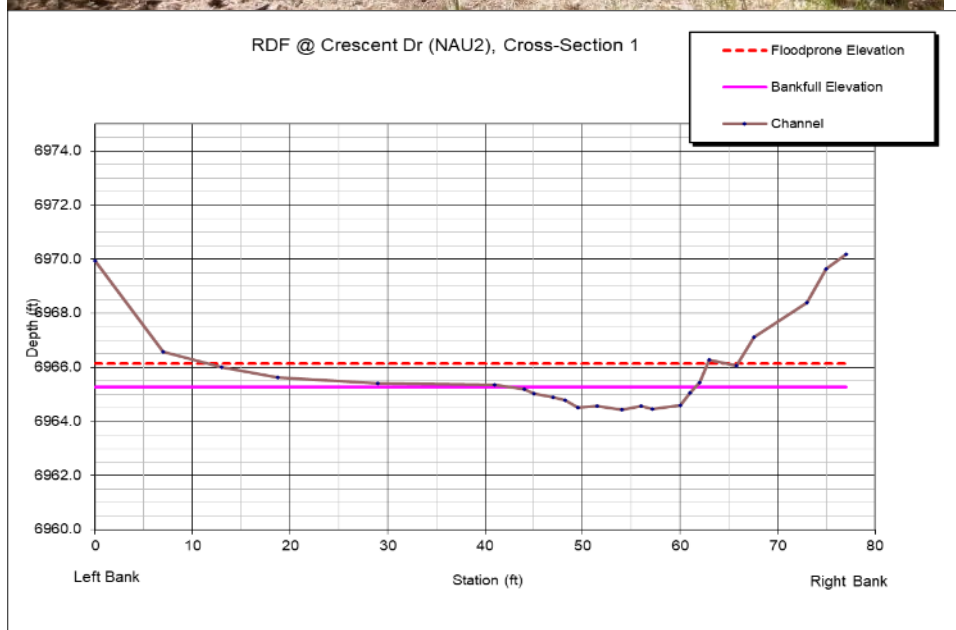
NAU 2 – RDF @ CRESCENT DR

There was a consistent bankfull bench through the reach, with willows growing along the edge. The bankfull flow is approximately 24 cfs which corresponds to a return interval between a 2- and 5-year event based on the SF Peaks local curve. This area does have more urban runoff than sites upstream.

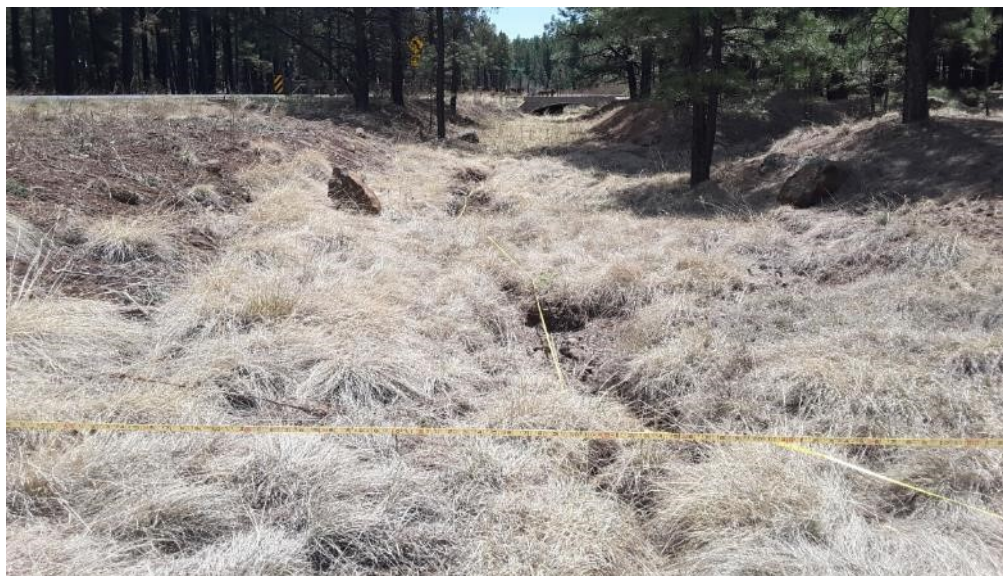
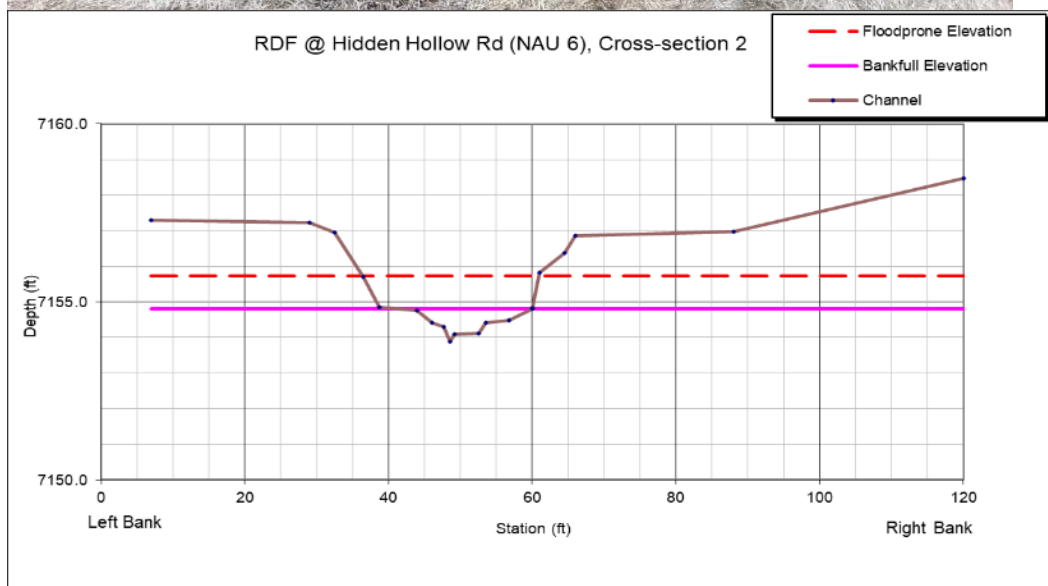
NAU 6 – RDF @ HIDDEN HOLLOW

Dense grass captures sediments and forms a bankfull bench. Estimated bankfull flow of 13 cfs corresponds with a return interval of just over 2-years on the SF Peaks local curve.

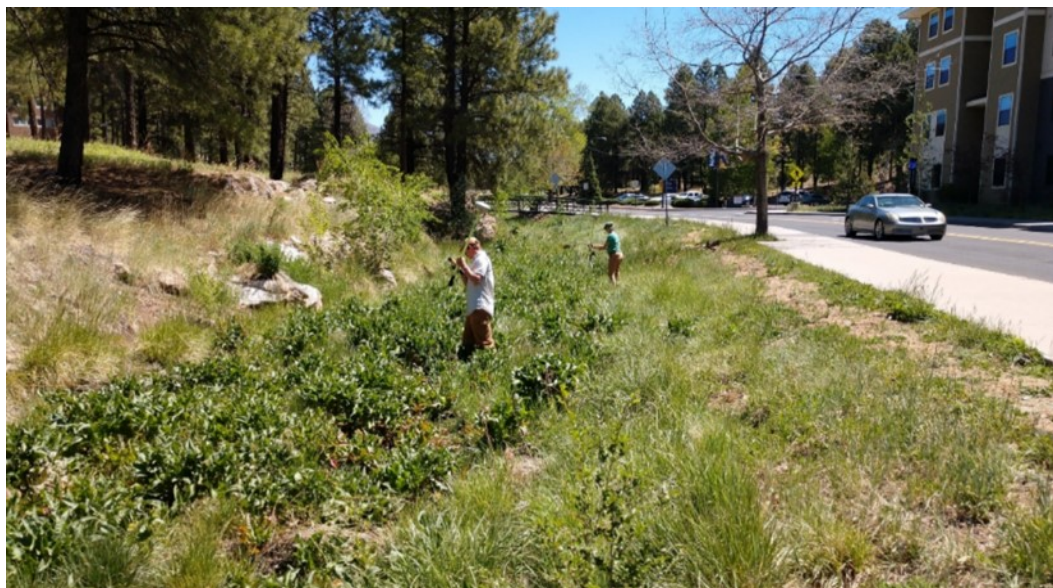
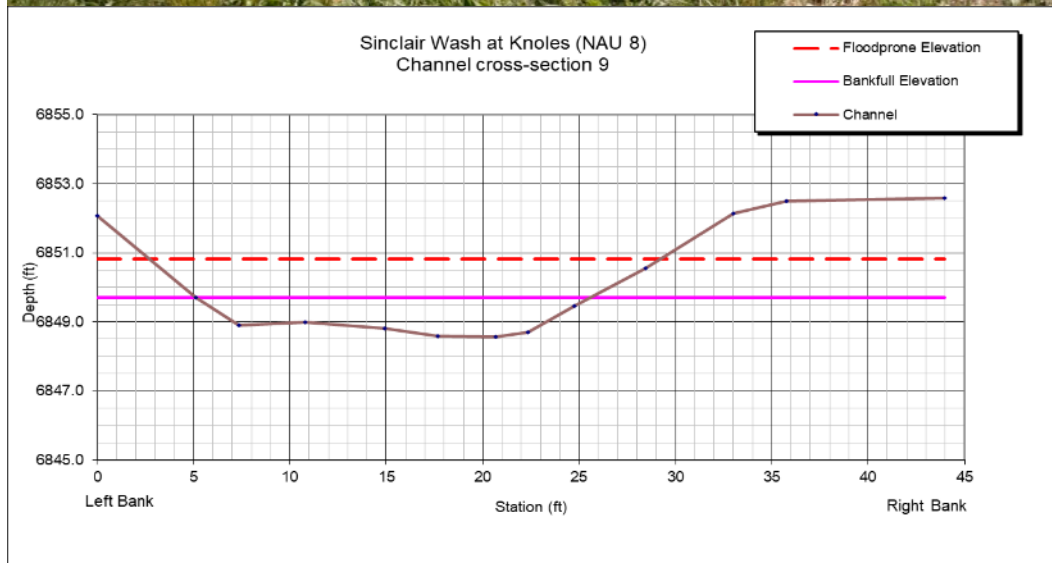
NAU 8 – SINCLAIR WASH @ KNOLLS DR.

Bankfull features almost non-existent. Highly modified, grass-lined channel is stable. Potential bankfull features included slope breaks and minor sediment deposits in grass. Bankfull flow is estimated at 30 cfs which corresponds to just under a 1.5 year return interval on the Urban Flagstaff curve.

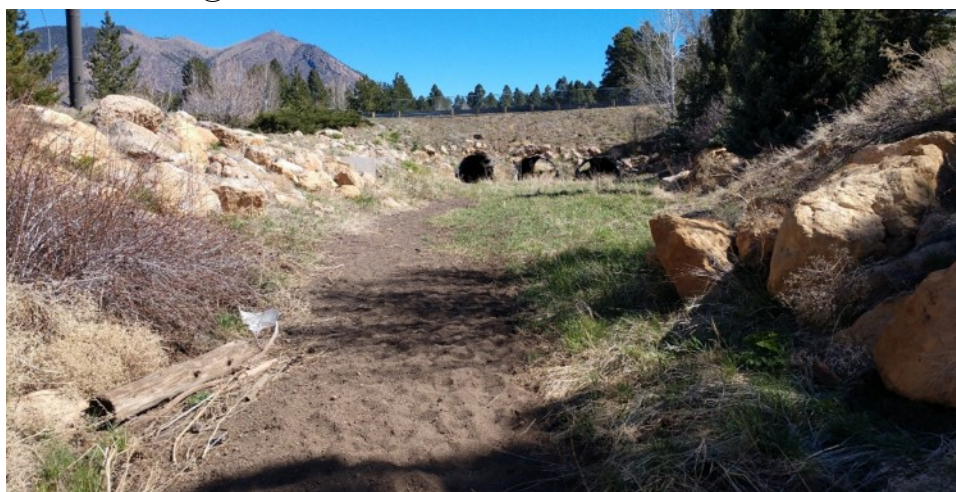
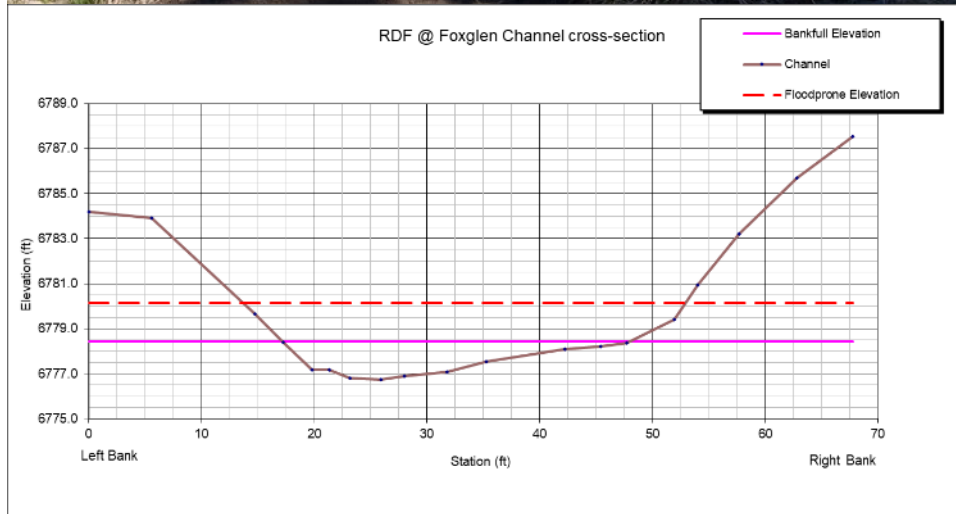
CITY 4 – RDF @ FOXGLEN PARK

Highly disturbed site with few reliable bankfull features seen. Indicators that were visible returned a bankfull flow of 63 cfs with a return interval of around 1.5 years utilizing the Urban Flagstaff Curve.

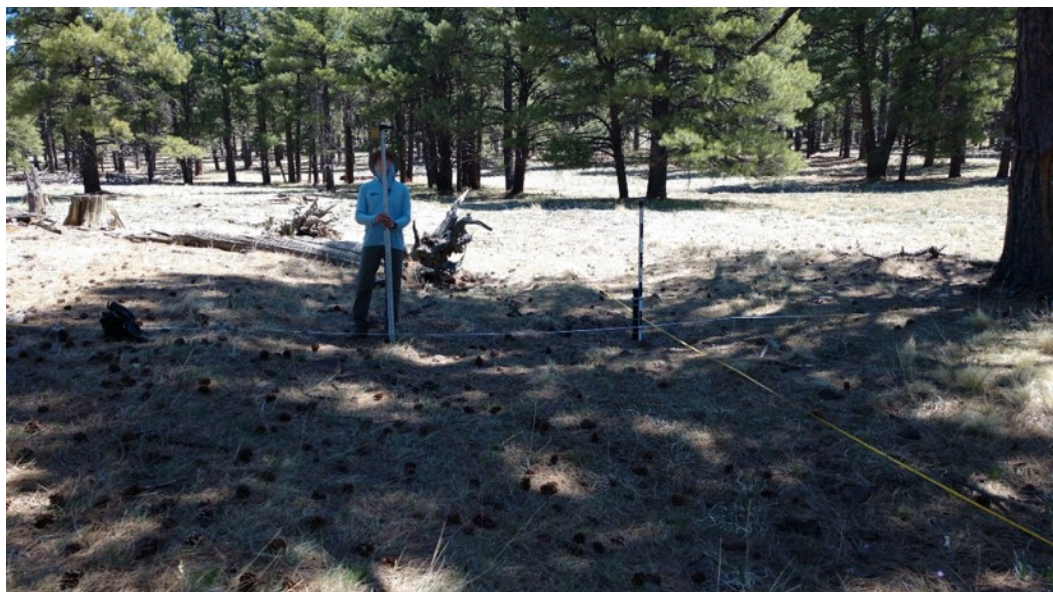
SRP 6 (LM 4)

Another very small watershed with unreliable bankfull features. Very flat and sheet flow just upstream. Best features result in a bankfull flow of 9 cfs.
